973 East State Street  
Ithaca, New York

Historic Structures Report

## **Condition Report**

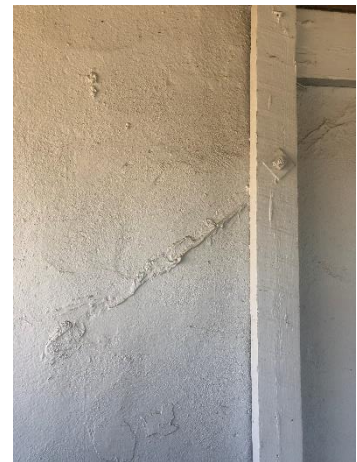
Overall, there is nothing that would indicate rising damp, nor any signs of bulging. There is no loose or detached stucco. There are some negligible fine cracks and depressions throughout. Previous repairs are visible in the form of thick patching to cover linear and diagonal cracks as well as smaller swaths of surface level damage.

The exterior walls rest on the foundation, beginning with terracotta blocking and a stucco finish construction, to possibly a wood stud and stucco finish at the first and second floors in order to reduce the weight. The field observations of the first and second floor walls did not reveal any signs of loose or detached stucco, or noticeable cracking or depressions. Moving vertically, there is

Fig. 41. Photograph by Claire Buchinger. *Exterior Stucco Patching*. April 2, 2023. Ithaca, New York.

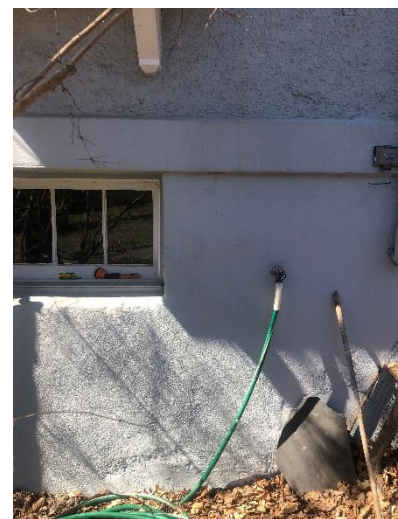
Fig. 42. Photograph by Claire Buchinger. *Staining at Belting*. April 2, 2023. Ithaca, New York.

possible water staining evident at both belting lines. There is no outward evidence of settling at the joists of the windows and doorways, which all appear to remain plumb and square.

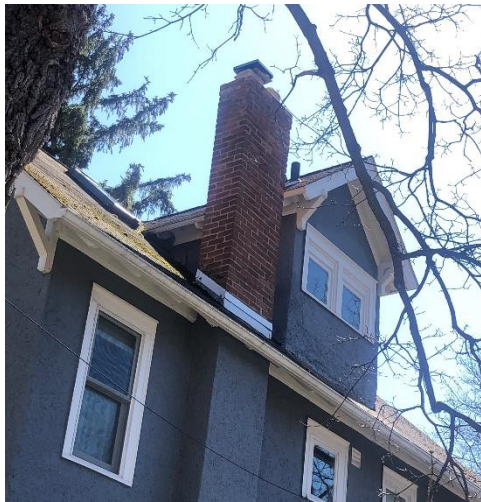
Fig. 43. Photograph by Claire Buchinger. *Biological Growth, West Façade*. April 2, 2023. Ithaca, New York.

and appears structurally sound with no sagging or cracking. The cornice and eaves are in excellent condition. Some biological growth is present at the east and west gable of the main roof due to the close proximity of tree cover. Similar growth is also present at the east and west dormers where the roof lines of the dormers meet the main gabled roof. Biological growth is most noticeable on the north facing side, which may get less sun. This organic material can be manually scraped

off. The walls of the dormers do not show evidence of detached or otherwise damaged stucco.

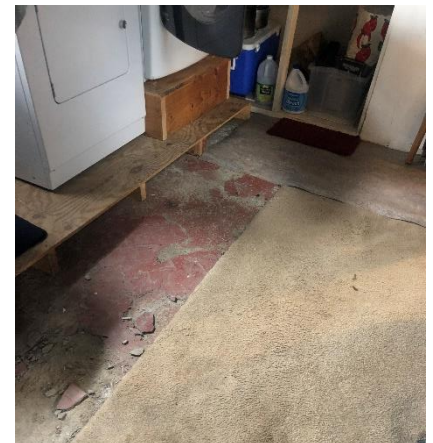
The leveling coat of the concrete flooring has broken away, taking with it some of the concrete surface. The concrete and concrete level coat may have sustained spalling and scabbing damage from past flooding as the entry door to the south sits flush with the driveway, or from the moisture level of the earth underneath the structure, in addition to the water infiltration down the foundation walls. However, there is no scent or visual evidence of mildew present.

Fig. 44. Photograph by Claire Buchinger. *Concrete Spalling*. April 2, 2023. Ithaca, New York.

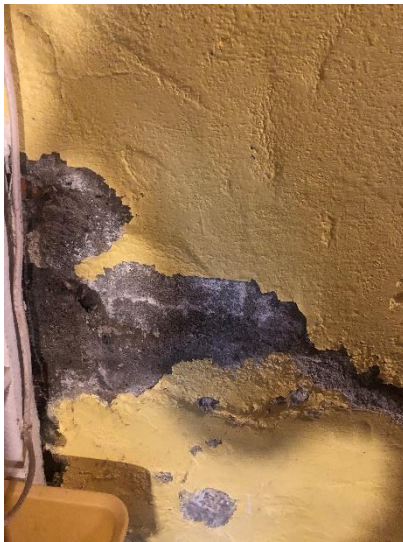
The stucco finish of the foundation walls is granulating, revealing the terracotta blocking underneath at the west window and at the foot of the stairs. A vertical crack runs through the

Fig. 45. Photograph by Claire Buchinger. *Foundation Damage, Stairs*. April 2, 2023. Ithaca, New York.

entire thickness of the wall underneath the west window. Stucco has detached where water infiltration has pooled. A moderate amount of horizontal crumbling is at the stairs, with patches of stucco detached. There is no sign of active groundwater infiltration. Spray foam insulation was used at the ceiling, where the venting, gas lines, and plumbing pipes travel. Expansion of the spray foam material may have shifted wood framing elements out of alignment.

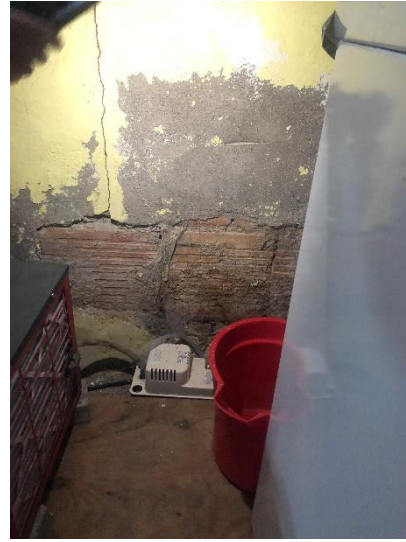
A live foundational crack rests underneath the west basement window, running through thickness of wall, possibly due to the settling or shifting of building materials or seismic activity. The condition of the crack is further addressed and photographed within the basement subsection, as the damage is most apparent from the interior.

Fig. 46. Photograph by Claire Buchinger. *Foundation Damage, West Window*. April 2, 2023. Ithaca, New York.

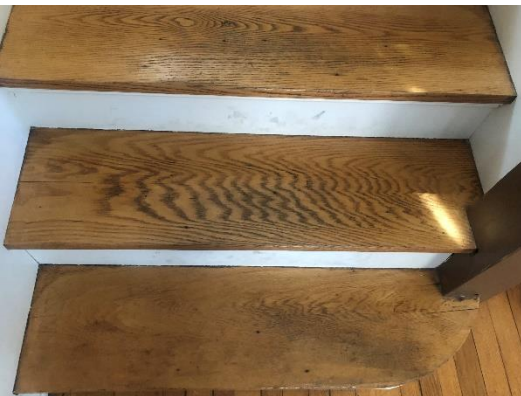
The L-shaped staircase integrated into the east wall leads up to the second floor. The risers are painted over, disguising any potential hints of damage or wear, and are topped with neatly polished wooden treads. There is some splitting along the grain pattern on the treads, yet no abrasion through either the center or edges of the steps. The staircase is in excellent condition, including the newel post, stringer, balusters, and wood paneling.

Fig. 47. Photograph by Claire Buchinger. *Wood Treads*. April 2, 2023. Ithaca, New York.

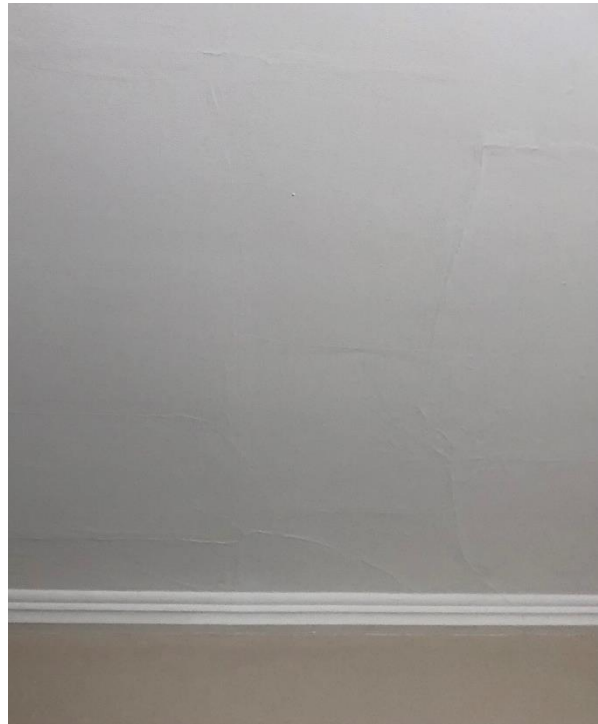
Fig. 48. Photograph by Claire Buchinger. *Plaster Settling above Vestibule Archway*. April 2, 2023. Ithaca, New York.

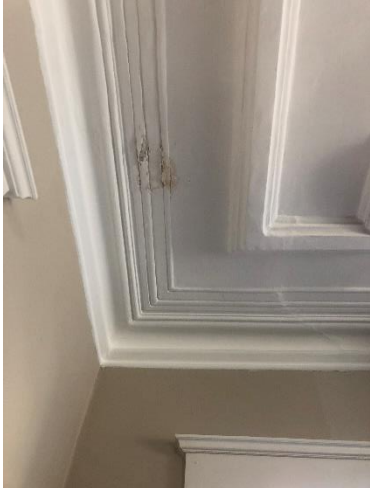
Fig. 49. Photograph by Claire Buchinger. *Living Room Water Damage, Facing West*. April 2, 2023. Ithaca, New York.

The first floor preservation objective is to maintain current conditions through routine maintenance and to identify the source of water infiltration in the southwest corner of the living room ceiling.

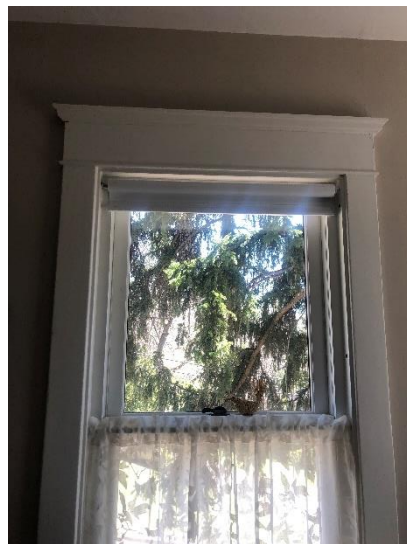
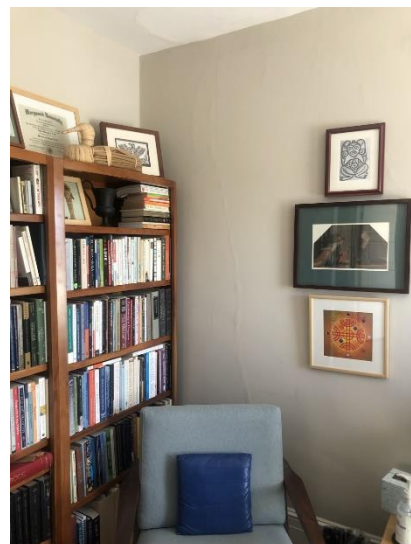
Fig. 52. Photograph by Claire Buchinger. *Settling at Joists*. April 2, 2023. Ithaca, New York.

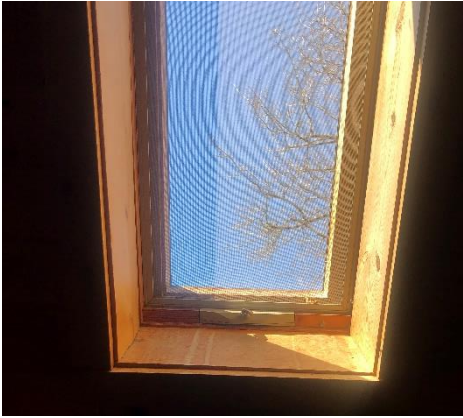
Fig. 54. Photograph by Claire Buchinger. *Water at Skylight*. April 2, 2023. Ithaca, New York.
