6010 Turnpike Rd, Trumansburg, NY

1: Inspection Detail	4
2: Roof	5
3: Exterior	12
4: Chimney, Fireplace, or Stove	25
5: Basement, Foundation, Crawlspace & Structure	27
6: Heating	32
7: Plumbing	35
8: Electrical	40
9: Bathrooms	46
10: Attic, Insulation & Ventilation	49
11: Doors, Windows & Interior	51
12: Laundry	59
13: Kitchen	61
Standard of Practice	64

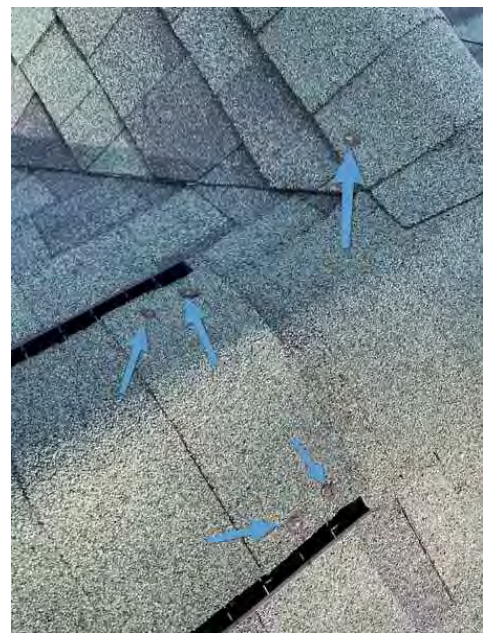
Middle of roof cap

**EXPOSED FASTENERS**

I observed indications of exposed fasteners at the roof-covering materials. Fasteners should not be exposed. Potential water entry points. Roof could leak. Further evaluation and correction is recommended.

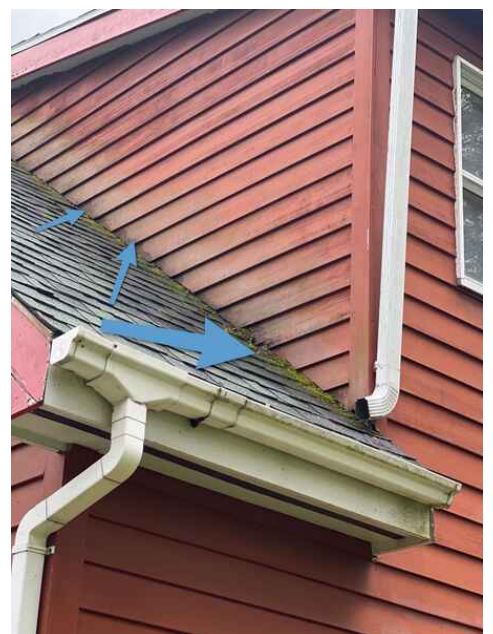
North

**MOSS OR OTHER ORGANIC MATERIAL ON ROOF**

I observed moss or other organic material on the roof. Recommend removal of the moss or organic materials. The moss or other organic material can hold moisture and could lead to premature failure of the roof system.

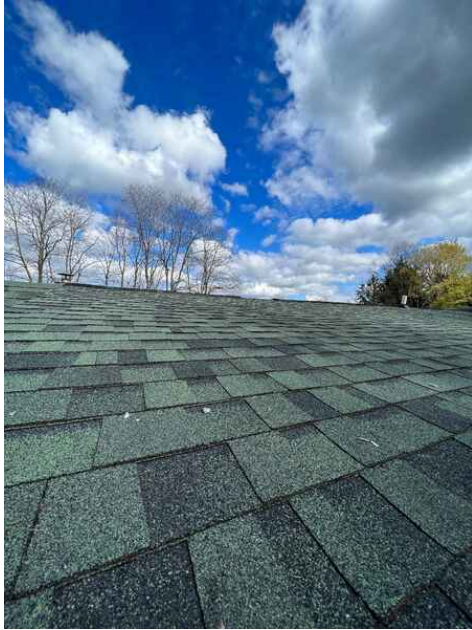
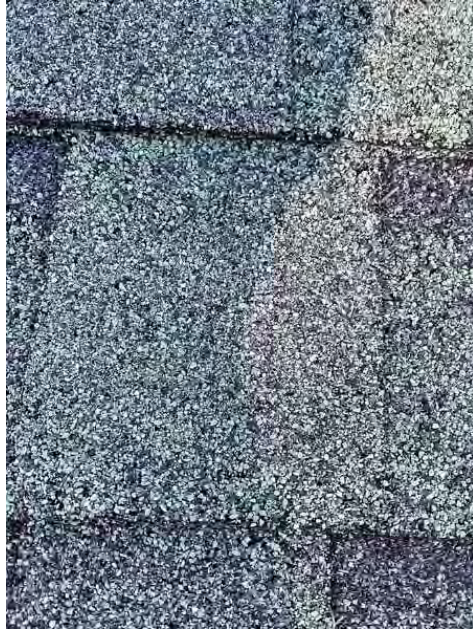
Minor Defect

Roof is older than 1 year old. I recommend monitoring roof.

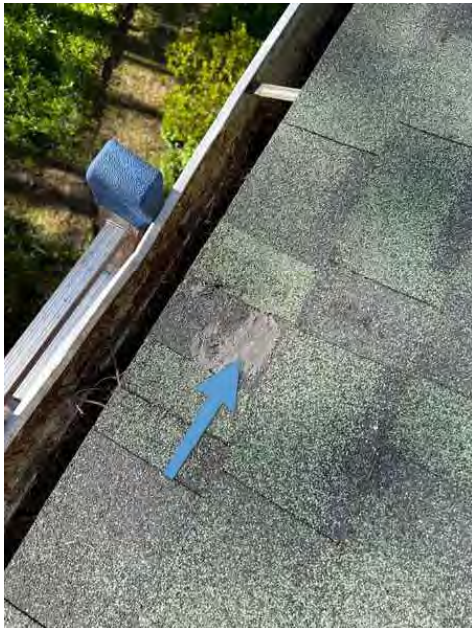
Northwest

PREVIOUS ROOF DAMAGE OR PATCH

I observed previous roof damage or repair. I recommend monitoring for future leaks.

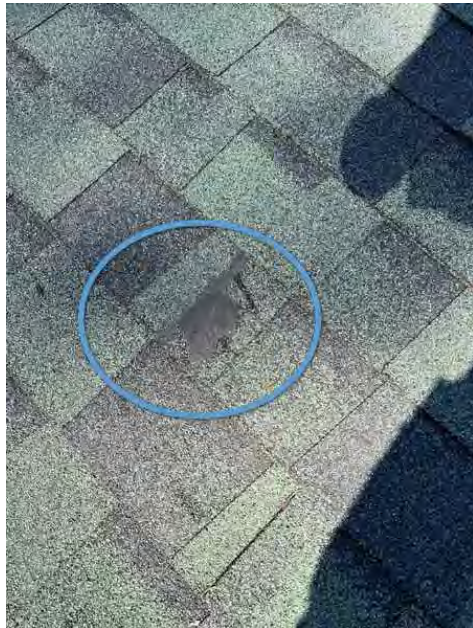
Northwest

2.3.1 Plumbing Vent Pipes

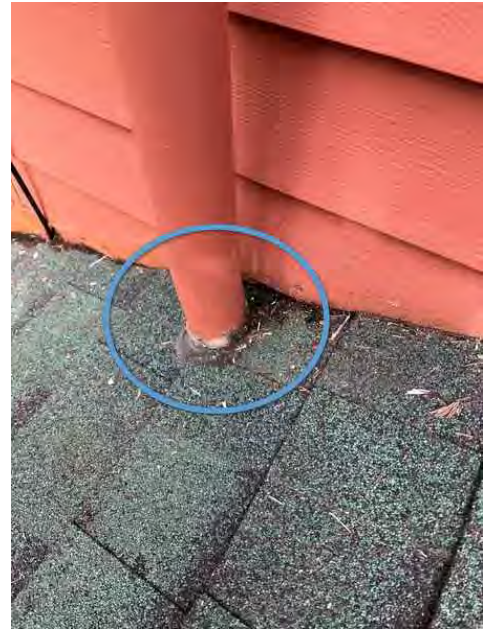
West

Minor Defect**FLASHING DEFECT**

I observed indications of a defect at the vent pipe flashing. The service entrance pipe was sealed with roof tar or caulking, this type of seal can eventually fail and become prone to water penetration or roof leak. This should be monitored and repaired if needed.

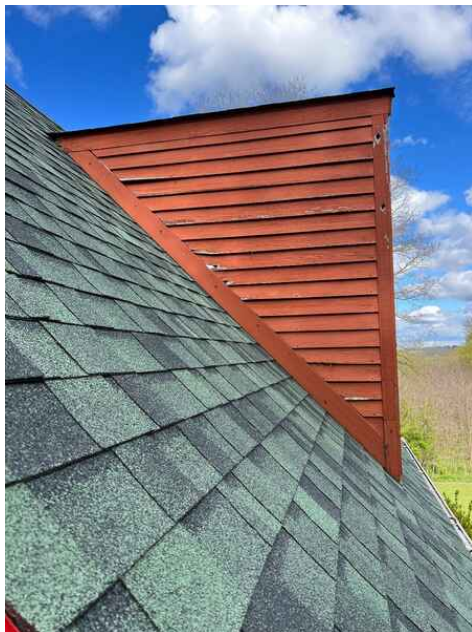
Dormer

I observed indications of a defect at the exterior wall-covering material. .

Correction and further evaluation is recommended.

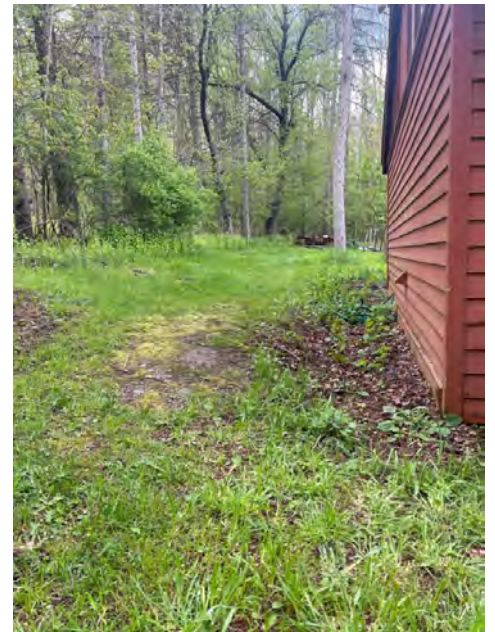
West

Grading is sloping towards the home in some areas. This could lead to water intrusion and foundation issues.

The ground around a house should slope away from all sides, ideally 6 inches for the first 10 feet from the house foundation perimeter. Downspouts, surface gutters and drains should also be directing water away from the foundation.

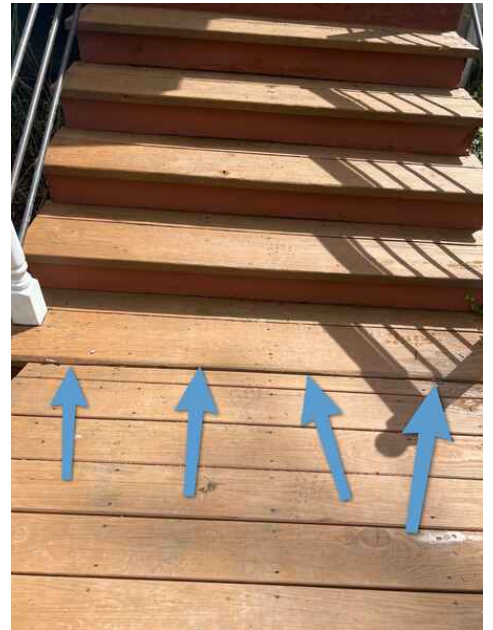
Front walk

TRIP HAZARD

I observed a trip hazard. This condition is a safety concern. Correction and further evaluation is recommended.

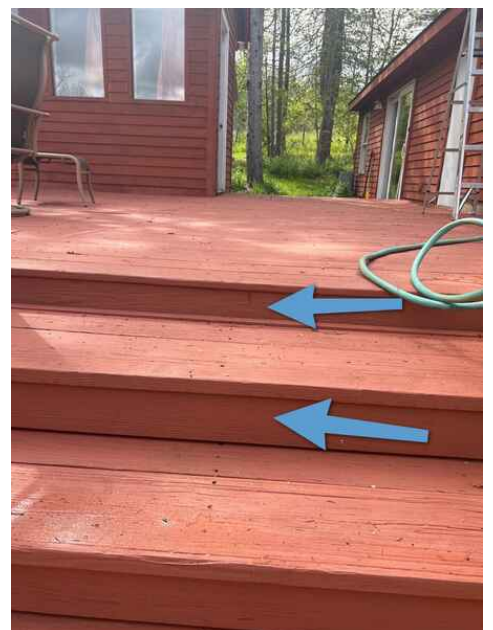
Southeast

I observed that there's a difference between the stair treads from one to another that is greater than 3/8 of an inch.

This poses as a trip hazard. The difference between one step and other is at most 3/8 of an inch.

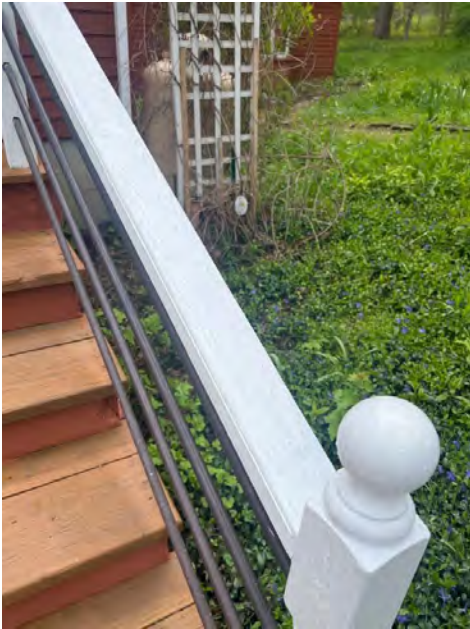
North

HANDRAIL NOT GRASPABLE

The handrails to the lake deck were not graspable. Recommend repair.

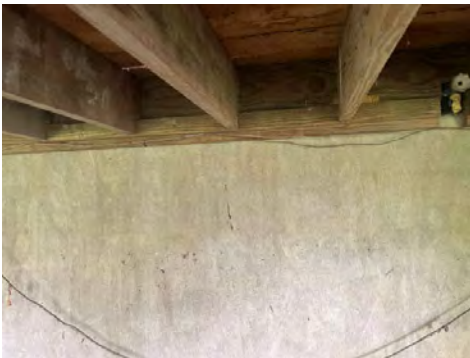
All Ledger Boards on the house

The ledger board is not properly attached to the building. This can cause the deck to pull away from the building and possibly collapse.

Correction and further evaluation is recommended.

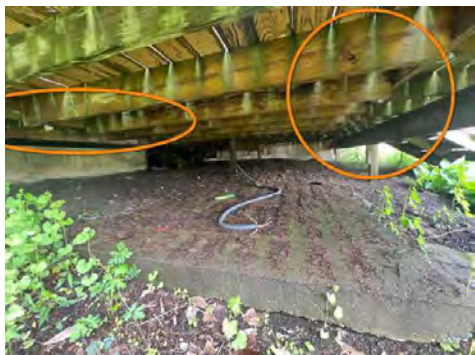
South

I observed a defect at the joist hangers of the deck, missing joist hangers. This condition is a major structural defect.

Correction and further evaluation is recommended.

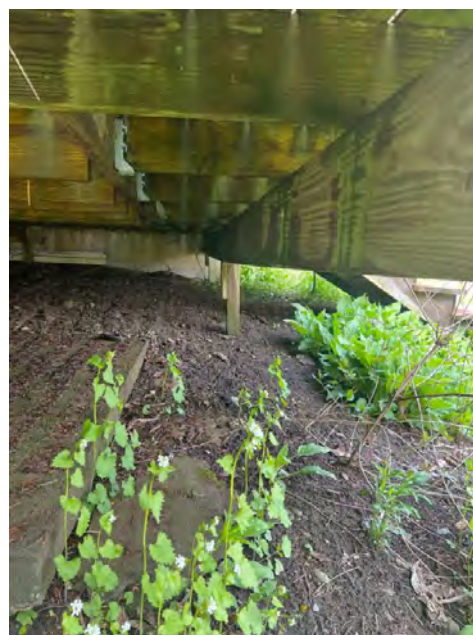
South

DECK SUPPORT

The south east deck beam has a bow and the beam attachment does not conform to standard construction practices (it should have 1 1/2" bearing and through bolted. I recommend a professional evaluate and repair if needed.

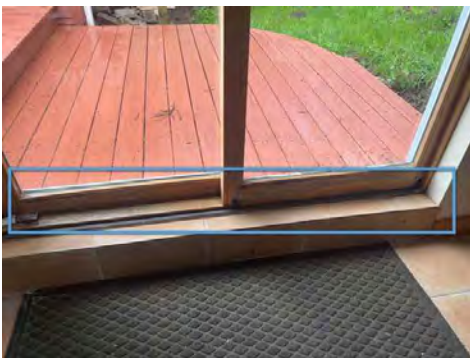
Southwest

Minor Defect

Correction and further evaluation is recommended.

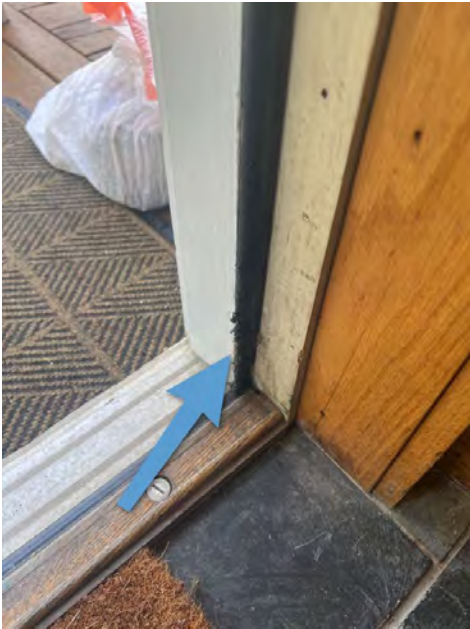
Front Door

Minor Defect

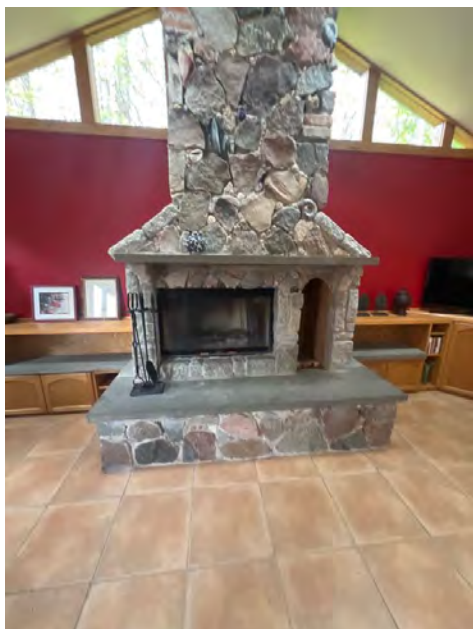
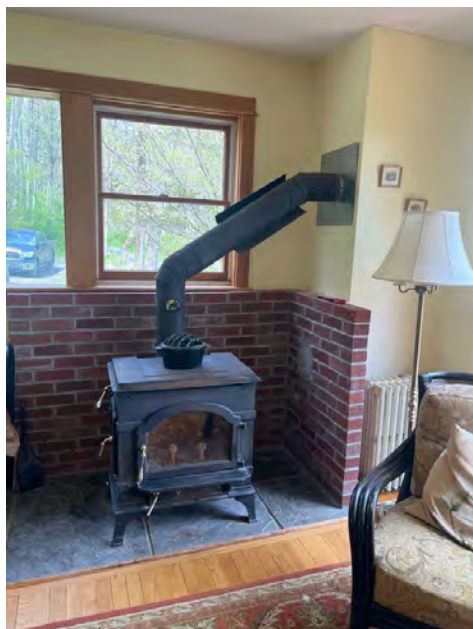
Masonry Chimney

COULD NOT SEE THE INTERIOR OF CHIMNEY

This is an inspection limitation. I recommend a professional evaluate chimney before use.

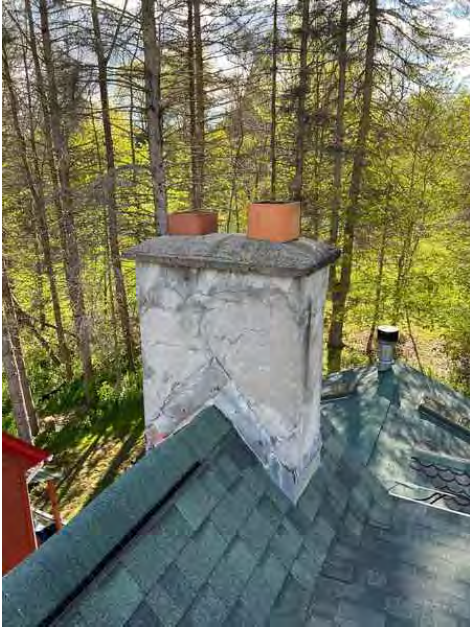
4.1.2 Masonry Chimney

CHIMNEY RAIN CAP MISSING

I observed a missing chimney rain cap.

The rain cap covers the top opening of the chimney flue liner.

SHOULD BE INSPECTED BY PROFESSIONAL BEFORE USE.

I recommend a professional chimney inspector inspect all chimneys before use.

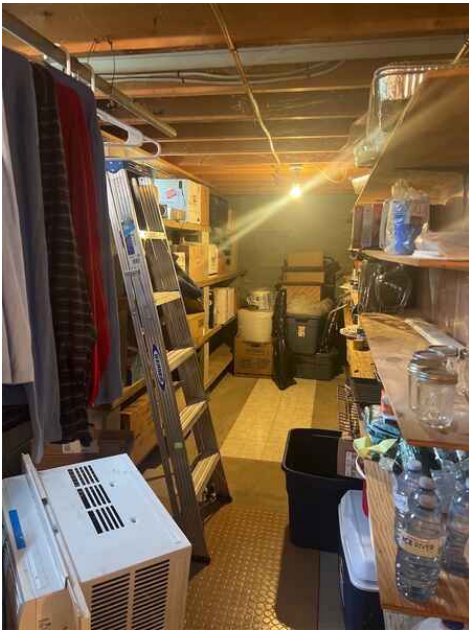
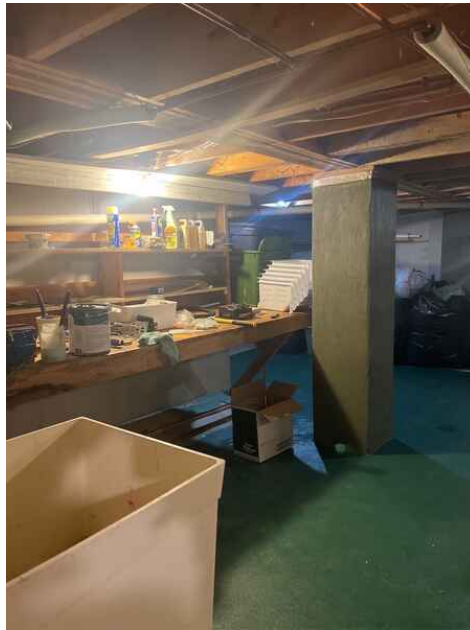
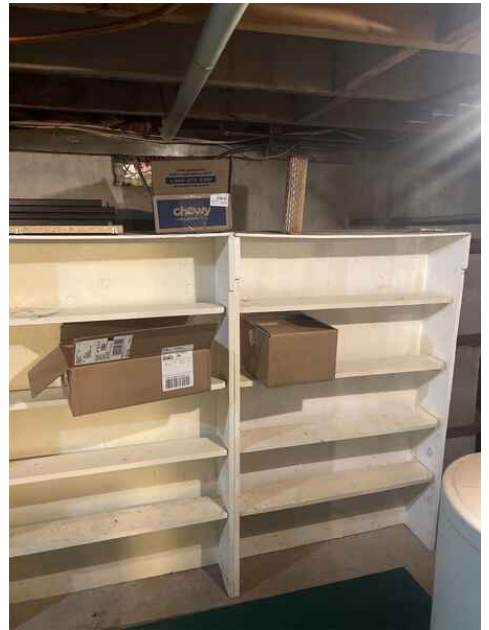
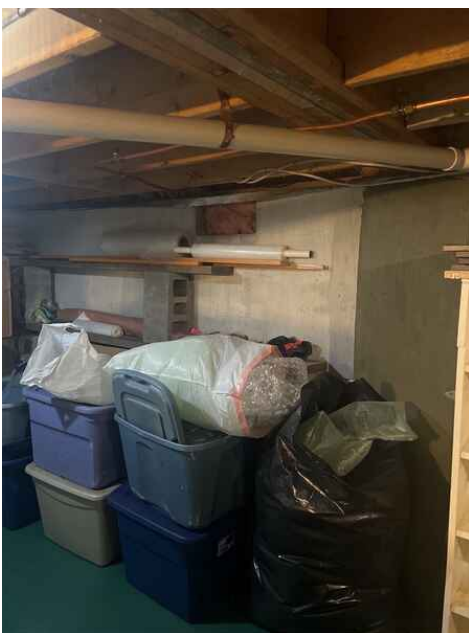
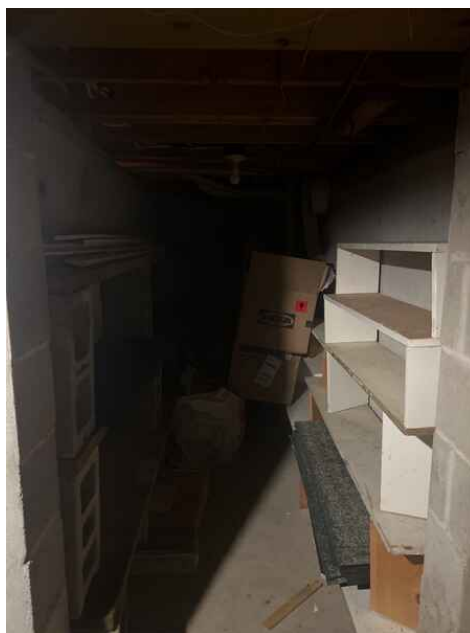
PERSONAL STORAGE RESTRICTION

Personal items limited my visual inspection. Moving personal items and storage is not required by the Standards of Practice. I could not see everything. Many things were blocking my inspection.

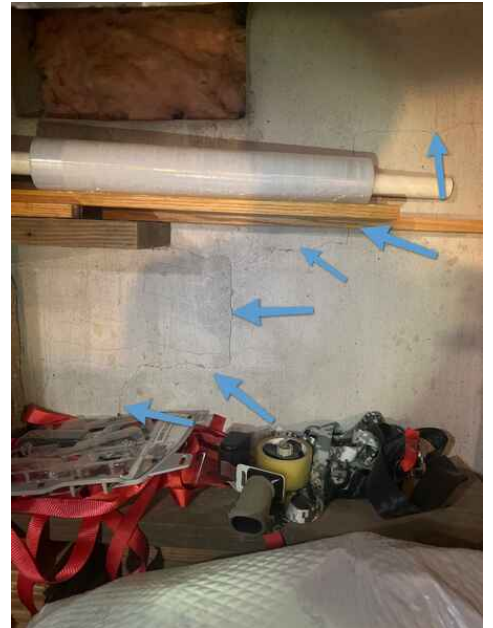
Basement South

I observed indications of possible foundation movement, I observed a small horizontal and vertical parallel crack in the basement exterior wall. I recommend monitoring and have a basement professional evaluate further.

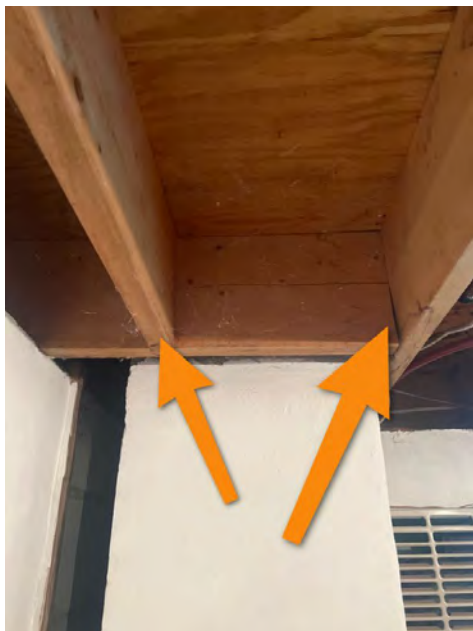
Basement Northeast

MISSING JOIST HANGERS

I observed missing or improperly installed joist hangers.

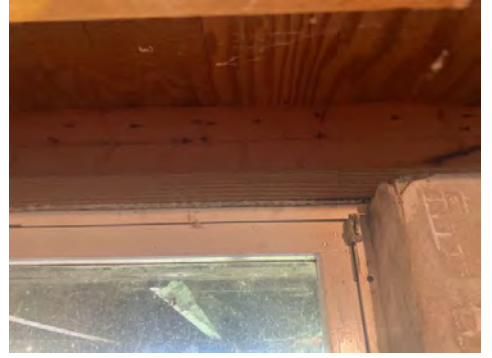
5.2.1 Insulation in Foundation/Basement Area

GENERAL ABSENCE OF INSULATION

I observed indications of the general absence of insulation in the foundation area.

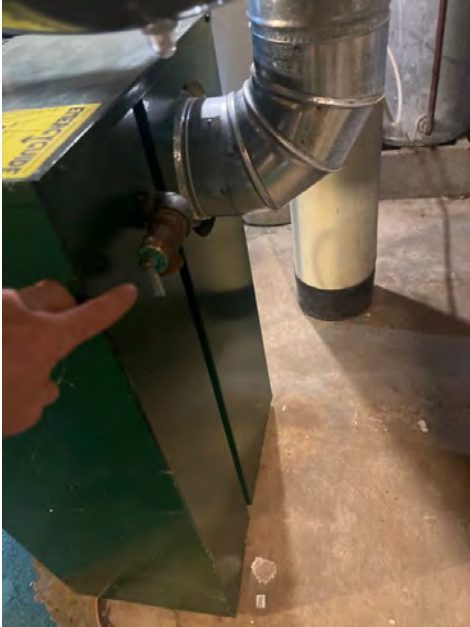
Defect

The TRP valve discharge did not extend within 6" of the floor. I recommend extending the TPR discharge pipe.

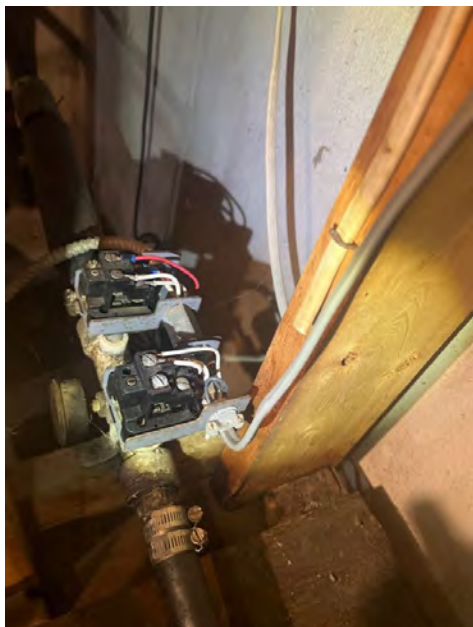
Material Defect

The well pump pressure switch cover was missing. This can cause an electrical shock. This is a safety hazard and should be repaired.

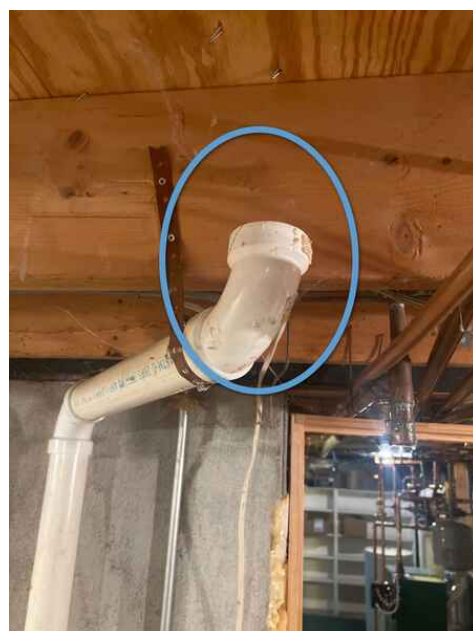
Basement Central

OPEN DRAIN PIPE

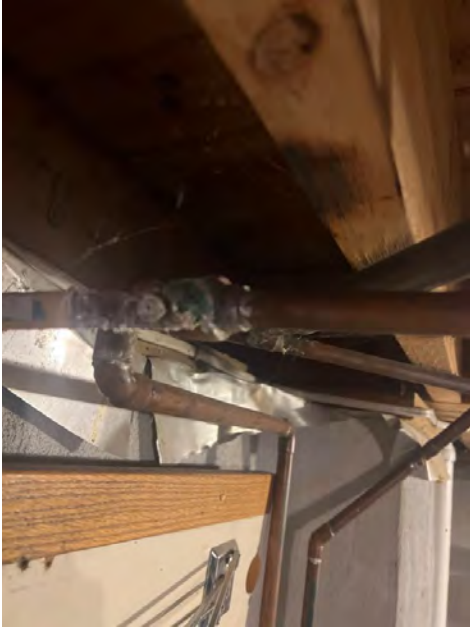
Laundry Sink Basement

CORROSION AT WATER SHUT-OFF VALVE

I observed a water leak that developed into corrosion at a water supply shut-off valve.

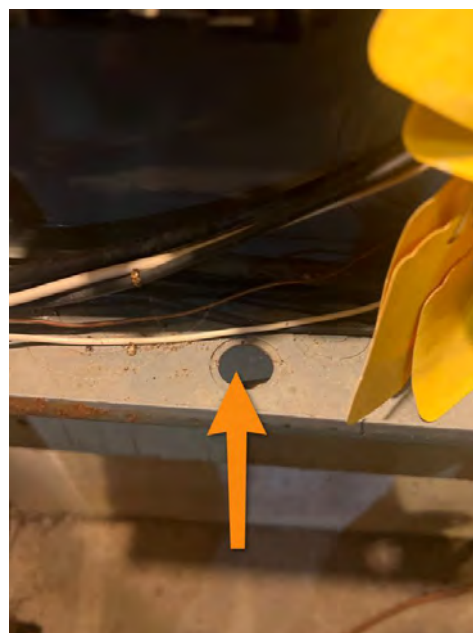
**KNOCKOUTS MISSING**

"Knockouts" are missing on the electric panel. This poses a safety hazard and it is recommended that the opening in the panel caused by the missing knockout(s) be properly sealed by a licensed electrician.

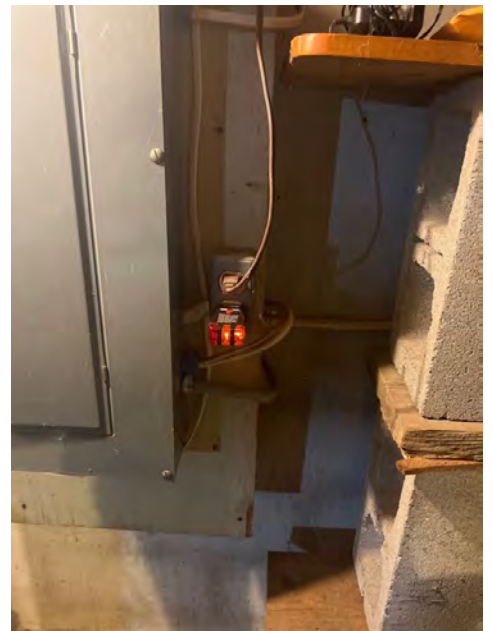
MISSING GFCI AT PANEL

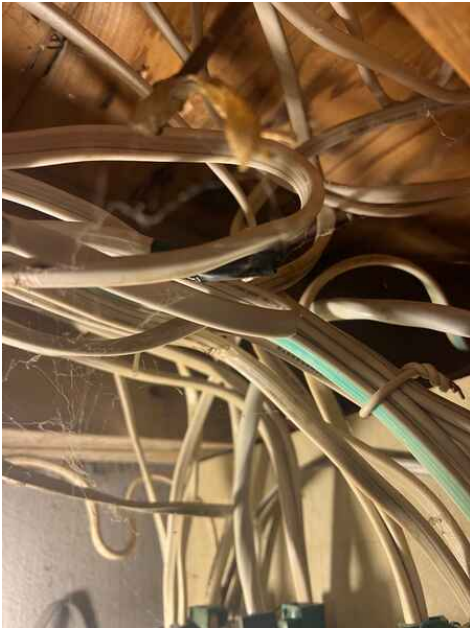
Above Electric Panel

OPEN/EXPOSED WIRE

I observed one or more wires that are open or exposed (not terminated in a box). I recommend an electrician terminate or remove the open or exposed wires.

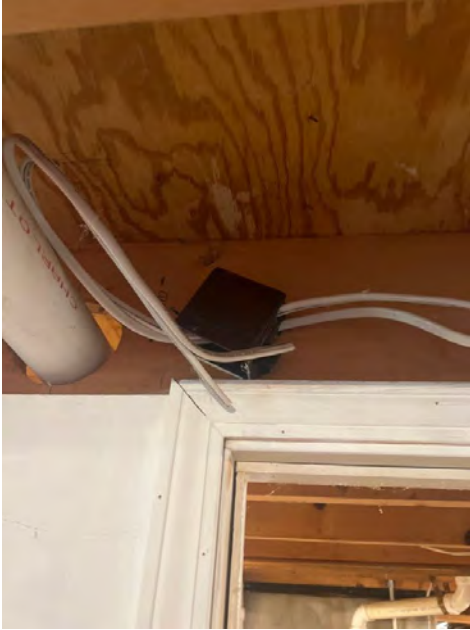
Basement Middle

MISSING COVER

I observed one or more outlets or junctions boxes without a cover. This is a potential fire hazard and recommend an electrician evaluate and repair.

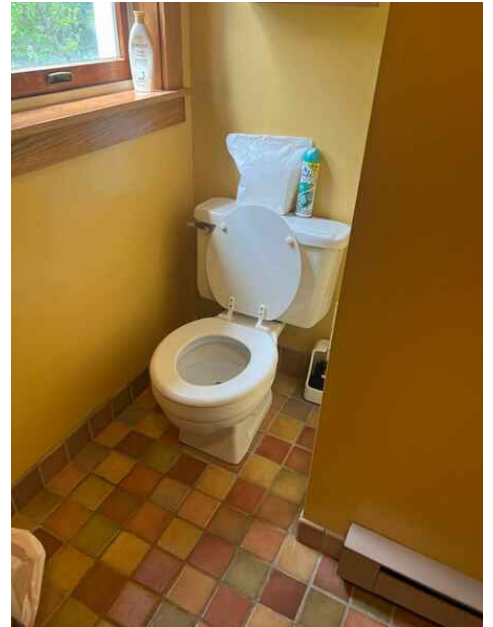
2nd Floor Bathroom

TOILET LOOSE AT BASE.

Toilet is loose at the base. Recommend plumber evaluate and repair.

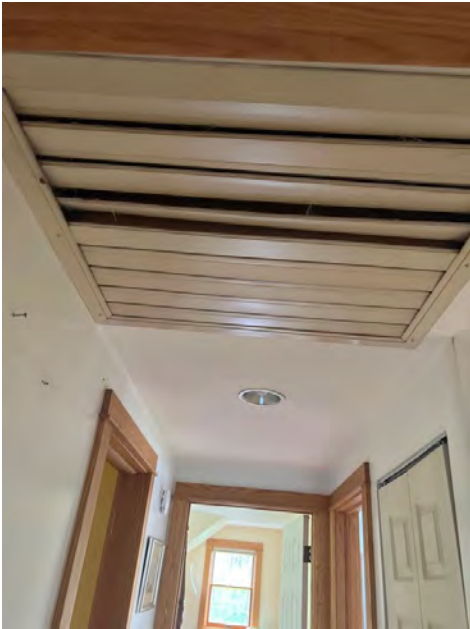
Insulation in Attic

COULD NOT ACCESS ATTIC

Access to the attic was restricted by the whole house fan.

UNABLE TO ACCESS OR SEE ALL OF THE ATTIC INSULATION

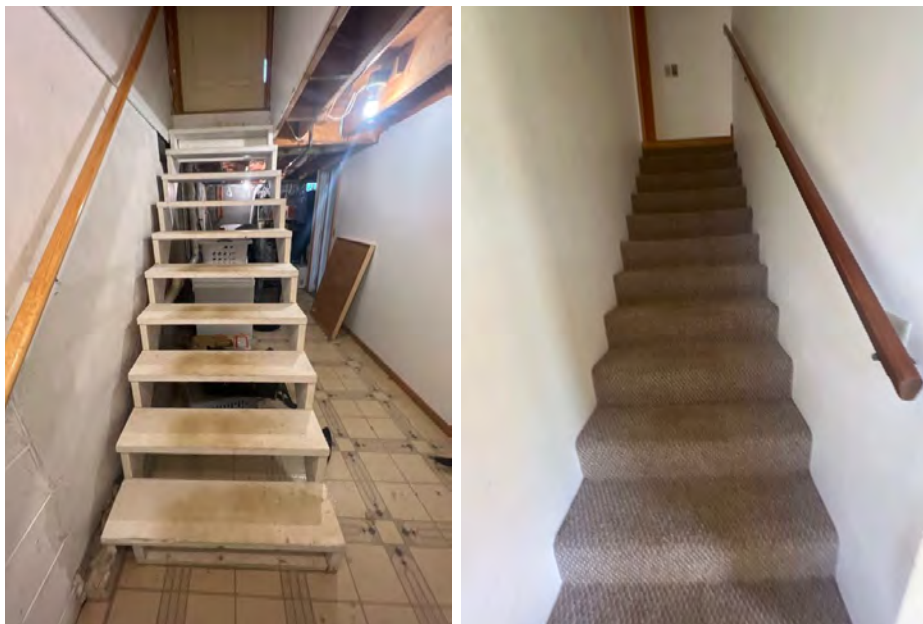
Stairs, Steps, Stoops, Stairways & Ramps: Stairs, Steps, Stoops, Stairways & Ramps Were Inspected

I inspected the stairs, steps, stoops, stairways and ramps that were within the scope of my home inspection.

All treads should be level and secure. Riser heights and tread depths should be as uniform as possible. As a guide, stairs must have a maximum riser of 7-3/4 inches and a minimum tread of 10 inches.

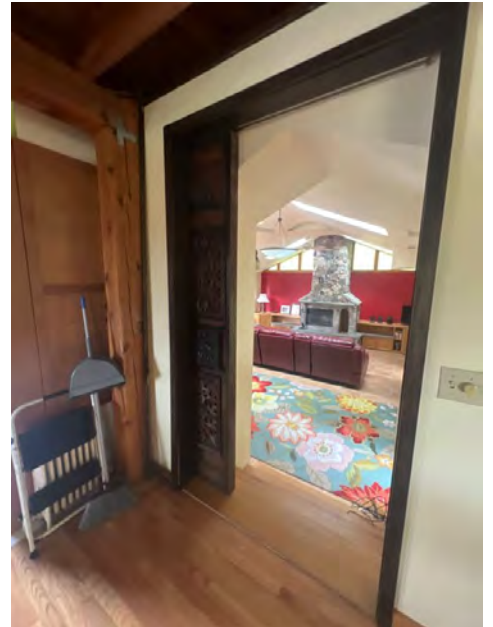
Pocket door to great room

DOOR STICKS OR IS HARD TO OPERATE

I observed the door sticks or is hard to operate.

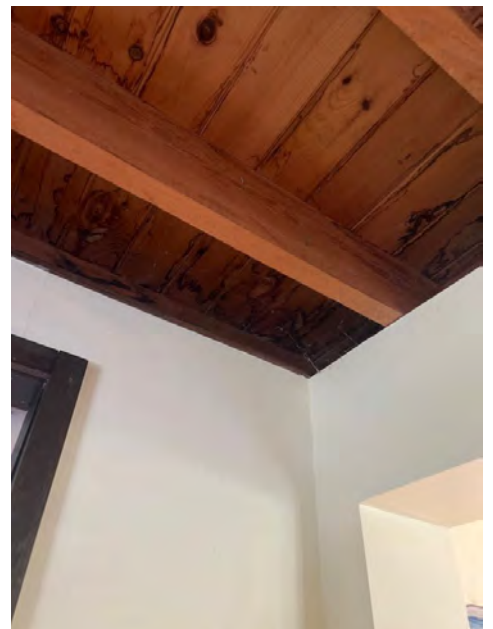
Northwest Dining Room

STAIN(S) ON CEILING

There is a stain on ceiling/wall that requires repair and paint. Source of staining should be determined.

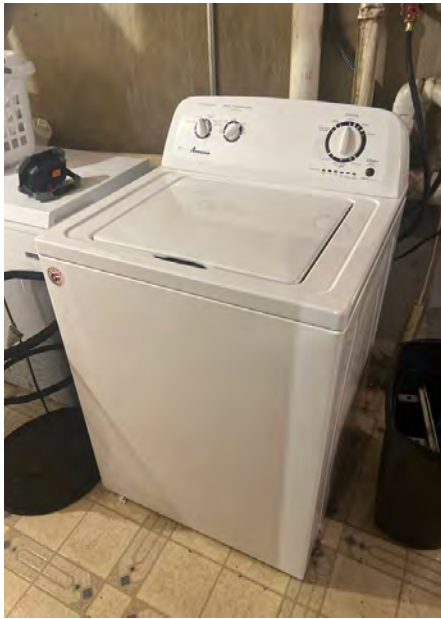
Clothes Washer: Washer Brand
Amana

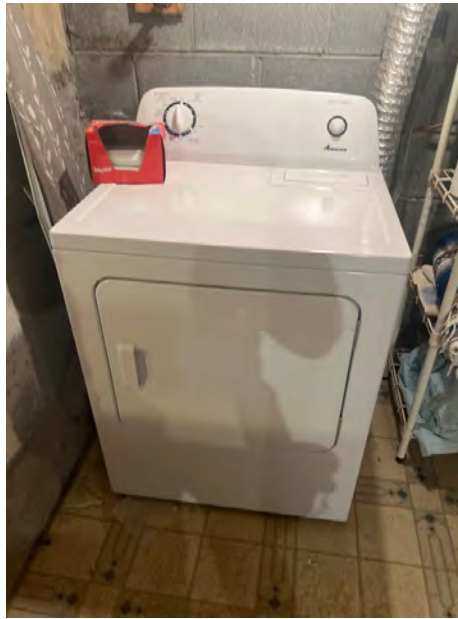
Clothes Dryer: Dryer Brand
Amana

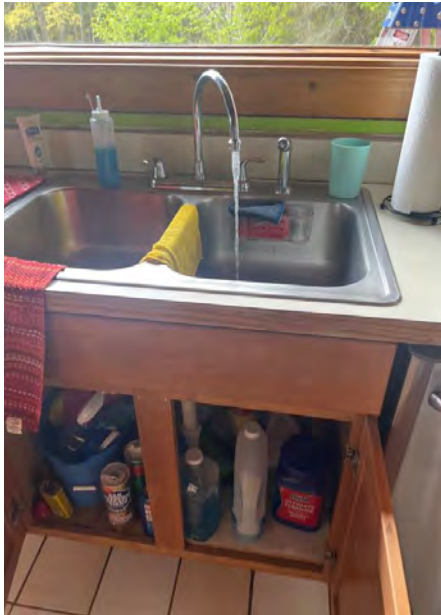
Kitchen Sink: Ran Water at Kitchen Sink

I ran water at the kitchen sink.

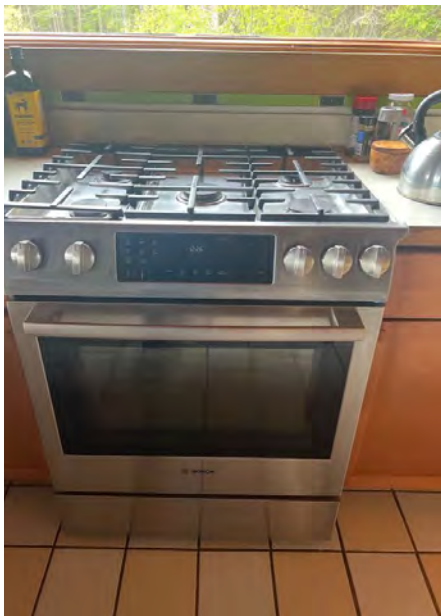
Range/Oven/Cooktop: Manufaturer

Bosch

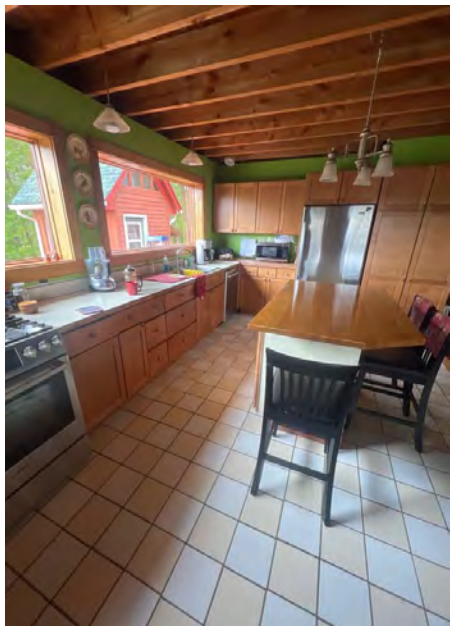
Countertops & Cabinets: Inspected Cabinets & Countertops

I inspected a representative number of cabinets and countertop surfaces.

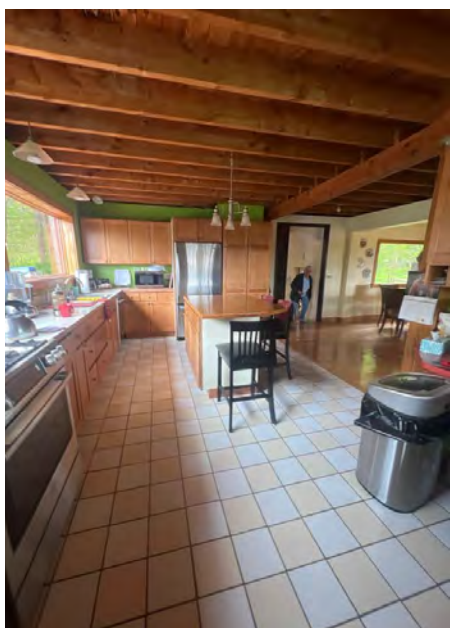
Floors, Walls, Ceilings: Floors, Walls, Ceilings Inspected

I inspected the readily visible surfaces of floors, walls and ceilings. I looked for material defects according to the [Home Inspection Standards of Practice](#).

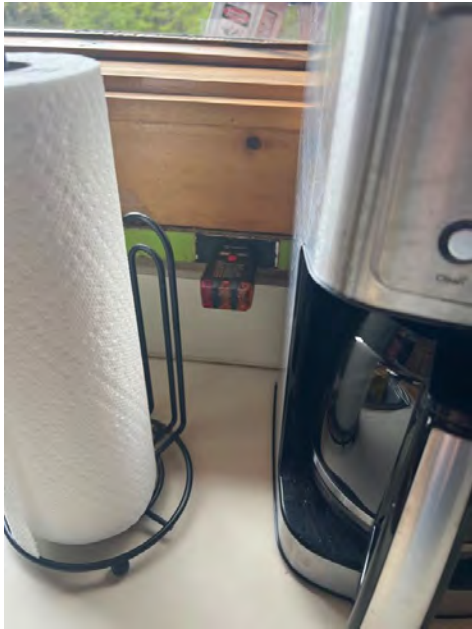
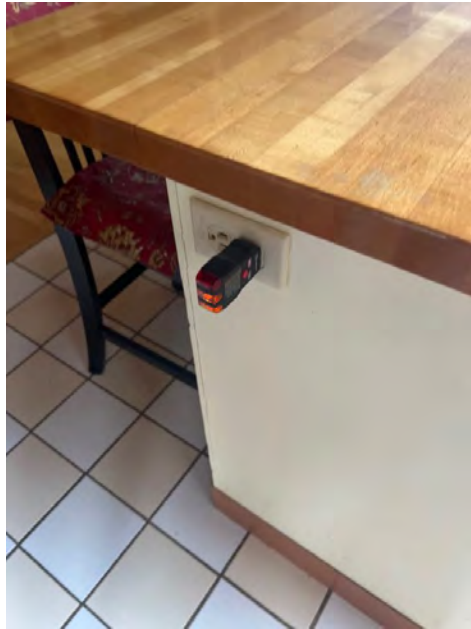
I observed indications of missing GFCI protection in the kitchen. All kitchen counter receptacles are required to be GFCI protected.
