973 East State Street  
Ithaca, New York

Historic Structures Report

## **Condition Report**

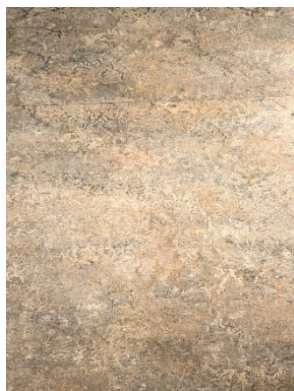
Fig. 26. Photograph by Claire Buchinger. *Kitchen Sheet Laminate*. February 25, 2023. Ithaca, New York.

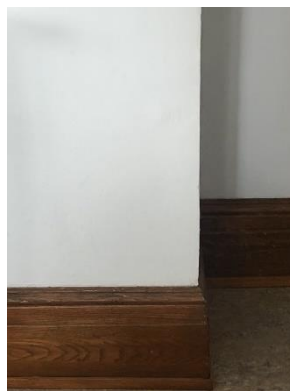
Fig. 27. Photograph by Claire Buchinger. *Kitchen Baseboards*. February 25, 2023. Ithaca, New York.

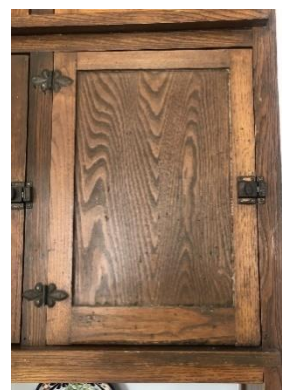
Fig. 28. Photograph by Claire Buchinger. *Kitchen Cabinetry*. February 25, 2023. Ithaca, New York.

The kitchen was renovated in the 1970s, and again in the 1990s-2000s. The original chestnut kitchen cabinets are one of the only original features to remain, and are marked by divots, depressions, and gouges consistent with their material, age, and use. There are knicks at the wood baseboards from traffic and wear. The kitchen's wood doors and windows follow the observations reported for the rest of the first floor. The remainder of the kitchen has been modified with non-historic materials and is not reported on.

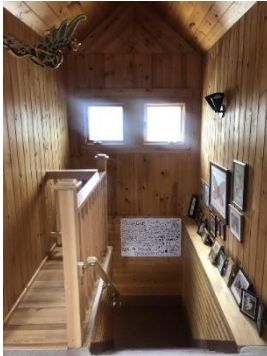
Fig. 37. Photograph by Claire Buchinger. *East Dormer*. February 25, 2023. Ithaca, New York.

Bulging has been noted at the east dormer, however, it is unclear if that is the result of deterioration or from patching over flashing.

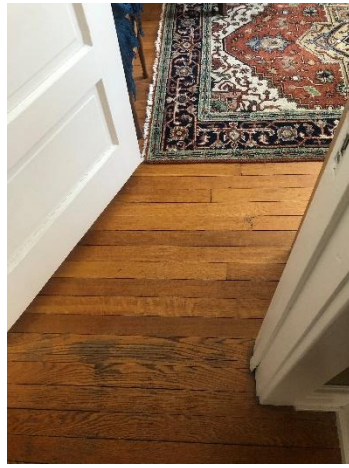
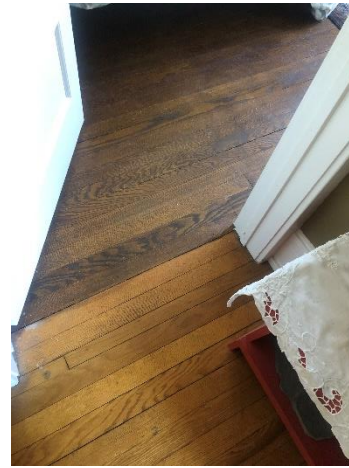
The oak plank flooring is continuous throughout second floor, until the marble hexagonal shaped penny tiling in the bathroom. The wood planks are level; they expand and contract depending on the season, creating temporary creaks. The hallway flooring material is original, as the finish stain or varnish has darkened with age and wear. The boards remain smooth, with no peeling or splitting. Although oak planking runs throughout, the dates of the flooring material vary as evident by a clear transition in color and graining from the hallway to the four bedrooms. The color and graining changes indicate newer replacement materials at the bedrooms, most

notably at bedroom #2 per figure 9. The flooring is penetrated at the bedrooms and bathroom by original cast iron floor grates, typically near the closets.

Fig. 50. Photograph by Claire Buchinger. *Second Floor Flooring Transitions*. April 2, 2023. Ithaca, New York.

Fig. 51. Photograph by Claire Buchinger. *Second Floor Flooring Transitions*. April 2, 2023. Ithaca, New York.
